## *Butterfly Handrail Replacement*

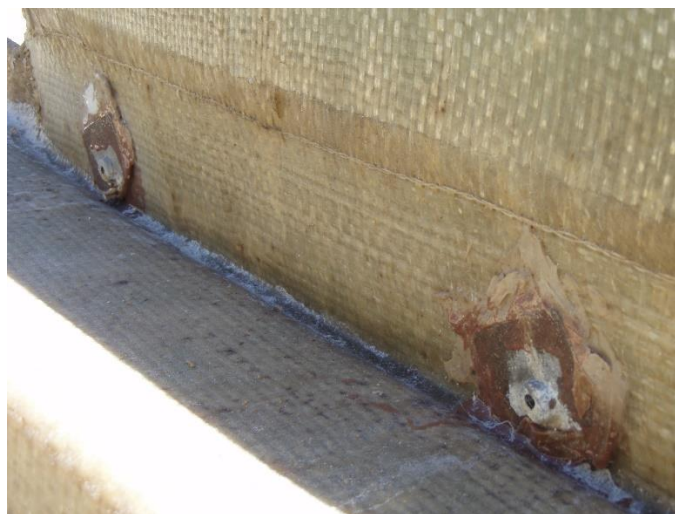
The handrail bolts are screwed into threaded aluminum backing plates, that are bedded in a polyester putty. See photo (it is the deck half of the boat, upside down, looking at one side of the cockpit - and in this photo, the handrail bolts have already been removed).

You should be able to turn the bolts out, but it may take some effort if the boat is really old due to oxidation around the stainless bolts and aluminum plates. But be careful to **TURN** hard, not **PUSH** hard, on the screwdriver. If you **PUSH** hard the backing plate can break out of the putty and the bolt will turn without coming out. If this happens, you have to drill a small hole next to the spacer block and insert something like a #8 or #10 pan head self-tapping screw, 3/4" long, into the backing plate to hold it in position while you try once again to turn the bolt out. If this is needed, the small screw comes out when you are done, and the hole filled with something like 5-minute epoxy. If you can find a plastic syringe used for fine epoxy work, you could even inject some epoxy into the hole to try to rebond the backing plate.

One trick to try to break the bolt loose if it is really stubborn is to heat the screwdriver with a torch, then hold it on the bolt head for a few seconds (so the bolt get hot) then try to turn it.

The good news is that the bolts really have turned out 99% of the time. The 1% that have failed have required using a hacksaw to cut through the wood spacer AND the bolt, then filing down the bolt flush with the cockpit. Now the handrails have to be re-positioned, its generally best to go down, by drilling new holes just below the old bolts and then using a tap from a tap & die set to tap new threads into the aluminum plate, and finally using new bolts to reassemble everything. For this trick, you would need new bolts and new spacers (we do have both) - but hopefully it doesn't come to this!
